## **Analysis of Collimation Field Size Accuracy and Beam Perpendicularity Test in the Apelem Camargue X-Ray Machine**

**Yusron Adi Utomo<sup>1\*</sup>, Imam Suyudi<sup>1</sup>, Heni Fa'riatul Aeni<sup>1</sup>, Ade Pitriyani<sup>1</sup>**

*<sup>1</sup>Sekolah Tinggi Ilmu Kesehatan Cirebon, Indonesia*

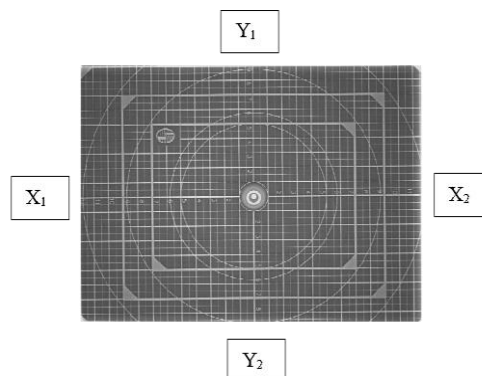
Figure 1. Radiographic image of the first conformity test (FFD 100 cm)

Axis	Light collimation field	X-ray field	Measurement deviation
X1	12 cm	11.9 cm	+0.1 cm
X2	12 cm	11.5 cm	+0.5 cm
Y1	9 cm	9.0 cm	0 cm
Y2	9 cm	8.7 cm	+0.3 cm

Based on the data presented in Table 1, the initial configuration of the light collimation field was set at 12 cm along the X1 axis and 12 cm along the X2 axis, as

well as 9 cm along both the Y1 and Y2 axes, in accordance with the predetermined field size parameters. However, following X-ray exposure and subsequent image evaluation, the measured dimensions of the resulting radiation field demonstrated discrepancies when compared with the preset light field dimensions across nearly all measured axes, except for the Y1 axis, which remained consistent with the initial setting. To quantitatively assess these discrepancies, deviations for each axis were calculated by determining the difference between the radiation field measurements and the corresponding light collimation field values. In this context, negative deviation values indicate an inward displacement of the radiation field relative to the light collimation field, whereas positive deviation values represent an outward expansion beyond the predefined light field boundaries, thereby providing a systematic basis for evaluating the accuracy and alignment of the collimation system.

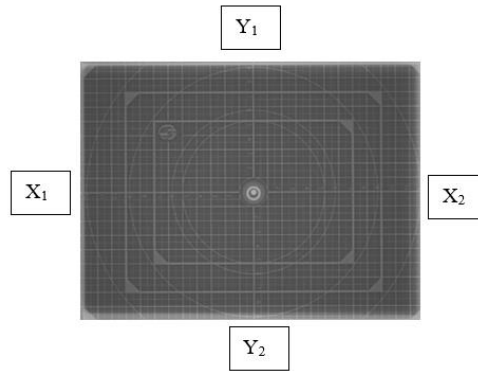
**Figure 2. Radiographic results of the second test (FFD 120 cm)**

Axis	Light field collimation	X-ray field	Measured deviation
X1	12 cm	12.1 cm	-0.1 cm
X2	12 cm	11.7 cm	+0.3 cm
Y1	9 cm	9.0 cm	0.0 cm
Y2	9 cm	8.5 cm	+0.5 cm

Based on Table 2, the light field collimation openings were set to 12 cm on the X1 axis, 12 cm on the X2 axis, 9 cm on the Y1 axis, and 9 cm on the Y2 axis. Following X-ray exposure, discrepancies between the light field and the radiation field were observed on all axes except the Y1 axis. The deviation for each axis was subsequently calculated, where negative values indicate inward displacement of the X-ray field relative to the light field, whereas positive values indicate outward displacement.

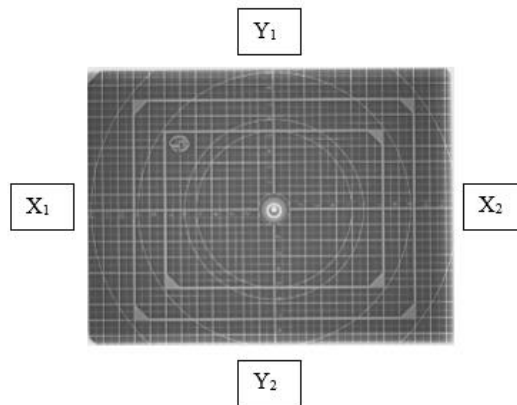
Figure 3. Radiographic image of the third test result (FFD 130 cm)

Axis	Light collimation field	X-ray field	Measurement difference
X1	12 cm	12.1 cm	-0.1 cm
X2	12 cm	11.5 cm	+0.5 cm
Y1	9 cm	9.0 cm	0.0 cm
Y2	9 cm	8.6 cm	+0.4 cm

Based on Table 3, the light collimation field was set to 12 cm on the X1 axis, 12 cm on the X2 axis, 9 cm on the Y1 axis, and 9 cm on the Y2 axis. After exposure, discrepancies were observed on all axes except the Y1 axis. Subsequently, the deviation for each axis was calculated. A negative (-) value indicates an inward displacement of the X-ray field relative to the light field, whereas a positive (+) value indicates an outward displacement.

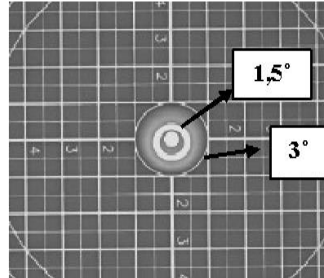
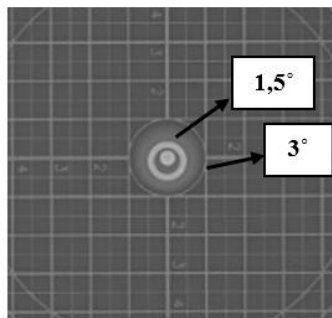
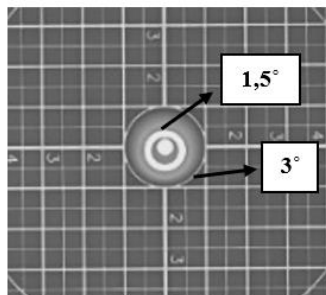
Following the completion of the beam perpendicularity tests, the results illustrated in Figures 4, 5, and 6 demonstrate that the central light beam consistently remained within the inner reference circle, indicating that the angular deviation did not exceed the permissible tolerance threshold of  $1.5^\circ$ . The assessment of beam perpendicularity was conducted through careful observation of the displacement of the steel ball marker relative to the concentric reference circles on the beam alignment test tool. The absence of marker displacement beyond the first reference circle confirms that the X-ray beam axis maintained a perpendicular orientation with respect to the image receptor surface. This finding signifies that the alignment between the collimation light field and the actual X-ray beam was geometrically accurate, thereby minimizing the potential for

FFD (cm)	Angular Deviation	Acceptance Limit $\leq 3^\circ$
100	0°	Yes
120	0°	Yes
130	0°	Yes

Based on the results presented in Table 5, it can be concluded that the collimator of the Apelem Camargue X-ray machine installed in the Integrated Emergency Department of RSD Gunung Jati Hospital, Cirebon, shows no deviation in the direction of the light beam. The measurements indicate an angular deviation of 0° at all evaluated focus-to-film distances (FFD), confirming that the beam perpendicularity fully complies with the established acceptance criteria.
